Getting Rid Of the Rubber Plug on a Dana 35

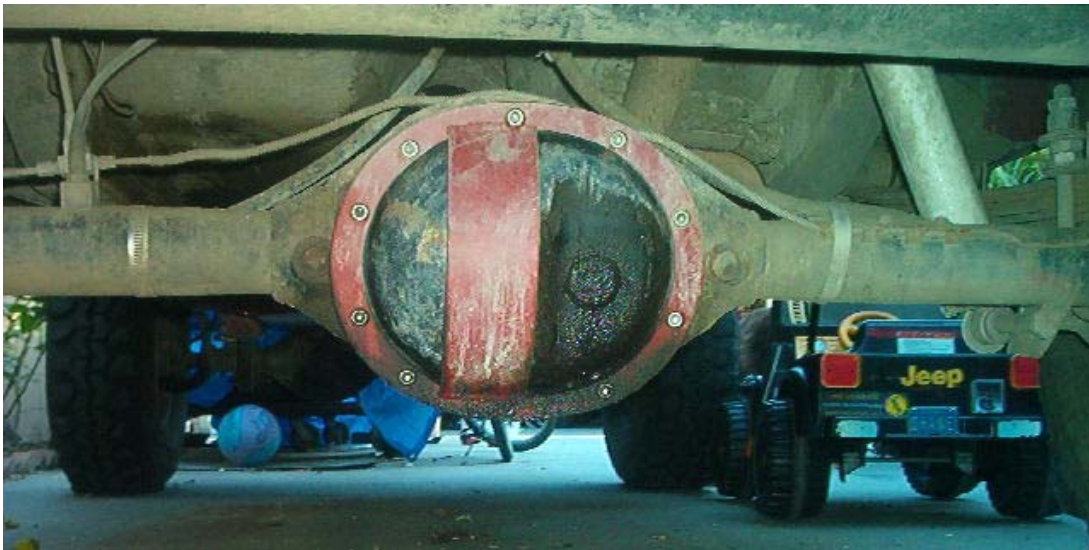
Here is what mine looked like. The rubber plug kept leaking and got oil all over everything

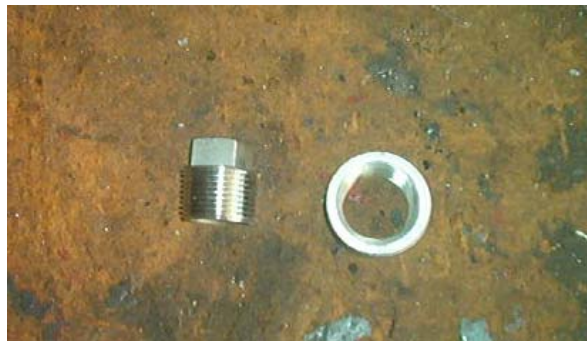
I order 1 ¼" Half coupler Stainless steel and 1 square plug stainless steel from www.MSCdirect.com. Part numbers were 08028979 and 08029761. I could not find a stainless steel ½ coupler from a local store
